AN OVERVIEW OF THE CRASH DYNAMICS FAILURE BEHAVIOR
OF METAL AND COMPOSITE AIRCRAFT STRUCTURES

Huey D. Carden
NASA Langley Research Center
Hampton, VA

SUMMARY

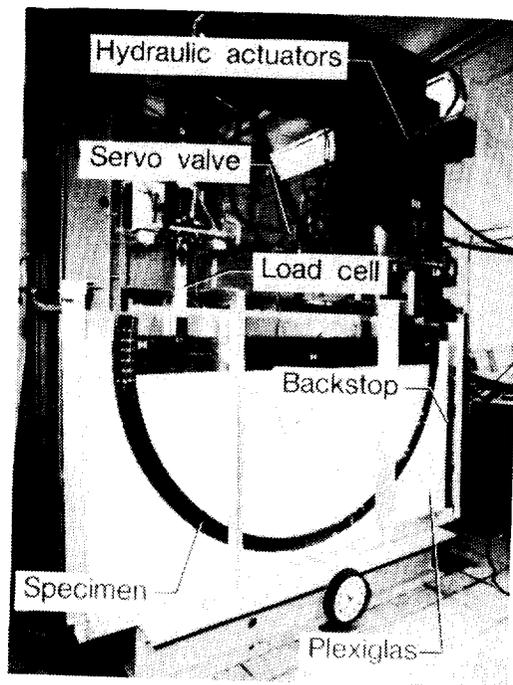
(a) Static test apparatus.

Static tests.- Figure 13 presents static results from tests of single composite Z-frames discussed in reference 26. A photograph of the static test apparatus in figure 13(a) shows that the splice plate was at the load point. The frame failed just outside the doubler splice plate area by a complete fracture across the Z-section. Load-deflection data and the location of failures of the frame are shown in figure 13(b). The load-deflection data show a saw-toothed behavior beginning with the essentially linear behavior of the frame up to initial failure with subsequent loading of the frame after failure being at a new, reduced stiffness for the damaged frame. Photographic data in figure 13(c) show that the initial failure was induced by a local buckling of the frame which occurred at about 18° from the bottom loading point outside the splice plate area. Second and third fractures occurred up the side at about 54° and 58° under continued loading as may be noted in the sketch at the right of figure 13(b). The sequence of events was local buckling near the splice plate induced out of plane deformations which led to a fracture of the section; the ends then remained in contact (jammed together under the compressive loads in the frame), the initial point of fracture moved vertically, essentially in a guided manner until two additional fractures occurred farther up the frame.

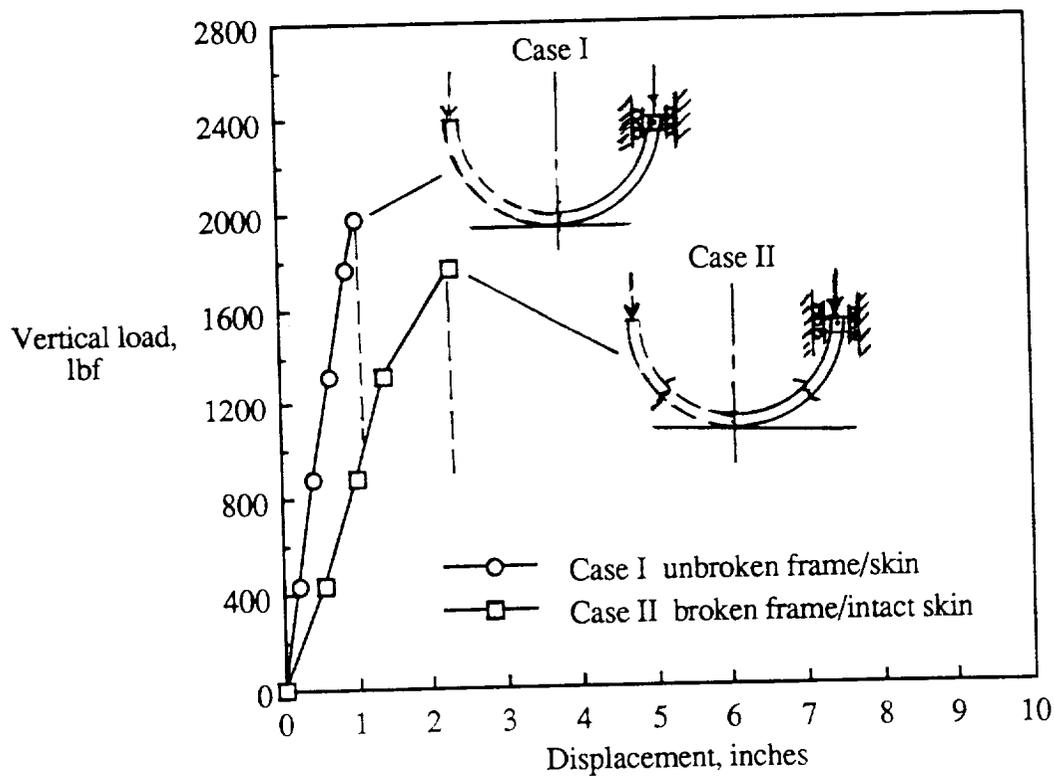
(a) Load-displacement.

Static analytical studies.- To demonstrate analytically the apparent behavior of the frames under load (exclusive of the local buckling which actually initiated the failure in the static case), a DYCAST finite element model was constructed. For ease of analysis, an I-section was modeled from the specimens described in the "Single Composite Frame" section. The frame was loaded at the top and a simulated ground plane (ground contact springs) resisted the vertical movement of the frame during load application. Boundary conditions were imposed at the bottom node of the model to account for the symmetrical situation thus only half the frame had to be modeled. The top node was constrained to allow only vertical displacement thus simulating the effect of a very stiff floor across the frame diameter. The static load was slowly increased until an input failure strain for the material (0.0086) was exceeded at the point of loading and failure was indicated. The curve labeled case I, *unbroken frame*, in figure 14(a) is the load-deflection plot for this case.

A comparison of the analytical cases (figure 14(a)) with the actual static load-deflection of the Z-section (figure 13(b)) indicates very similar load-deflection behavior patterns as discussed above. Although the Z-frame had no skin, if the ends jam together (as they did in several cases), the boundary is effectively between the skin stiffened case and a guided boundary. Thus, the predicted failure location in the simple beam-frame model at about 50° (See figure 14(b)) agrees well with the 54° and 58° failure locations in the experiment with the Z-section frame.

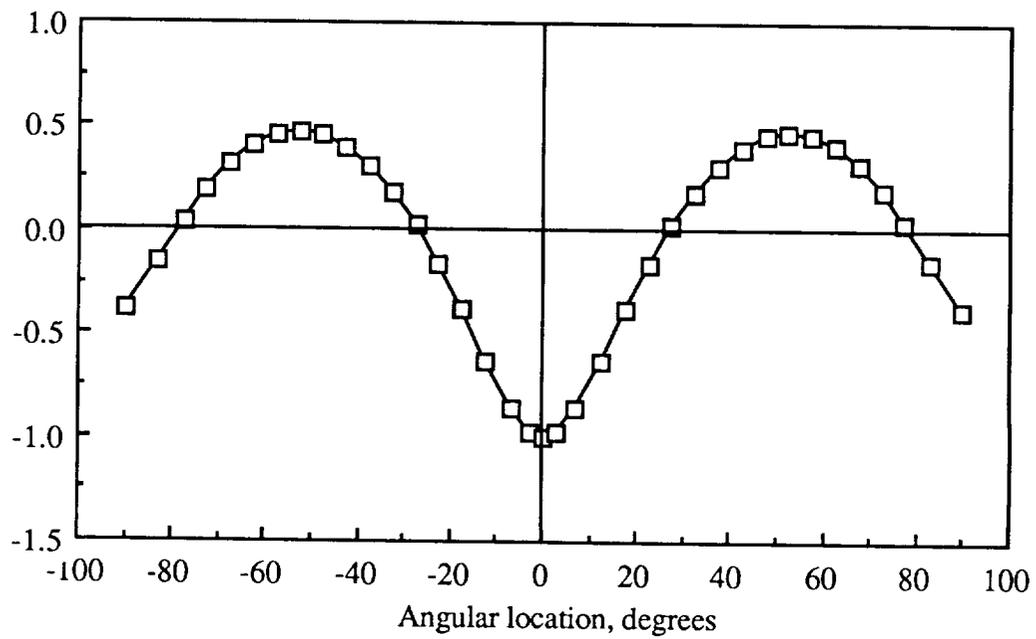
(b) Case I---Normalized moment (Prior to failure).

An examination of the normalized distribution of the bending moment on the frame shown in figure 14(b) provides insight and a better understanding of the failure/behavior. Maximum moments are indicated (just prior to failure) to be at the 0° location and between 50° - 60° from the bottom contact area. The locations correlate well with the failure locations in the experiment with the Z-frame.

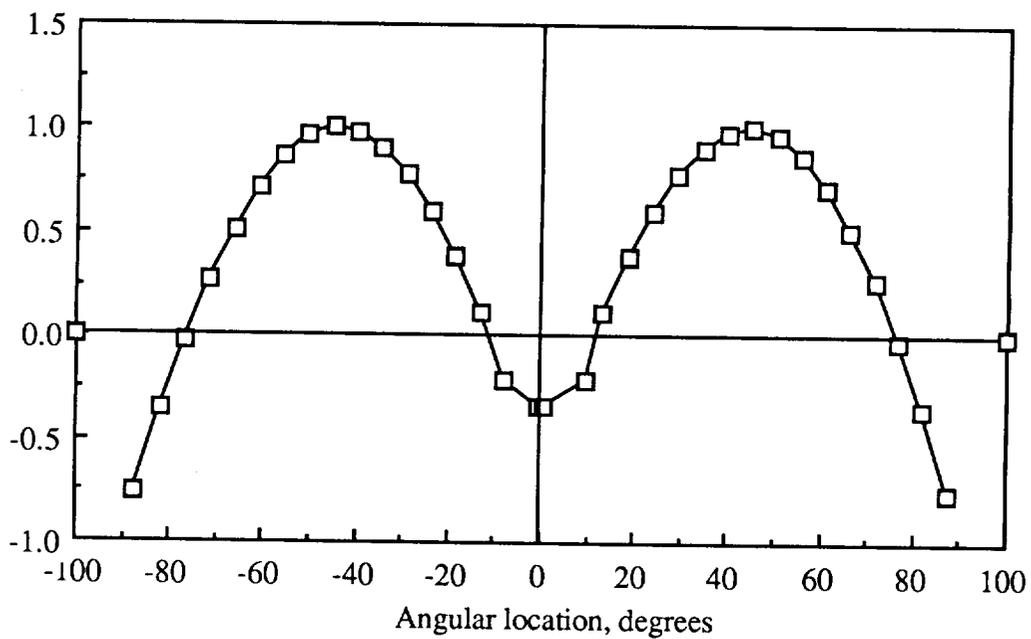
(c) Case II---Normalized moment (Broken frame-intact skin).

Figure 14(c) presents the normalized bending moment distribution on the broken frame. As may be noted, the distribution is quite similar to the initial model results in figure 14(b). The failure location is at the maximum bending moment location predicted to be about 45° which is somewhat lower than the same location shown in the initial model of the unbroken frame. The agreement between the two models, however, is still considered good. The effect of diameter on the moment distribution of the frame was assessed with a model having a 75 inch diameter (twice the initial diameter). The distribution was identical to the smaller diameter results; however, the loads producing the moments differed between the two models (as expected).

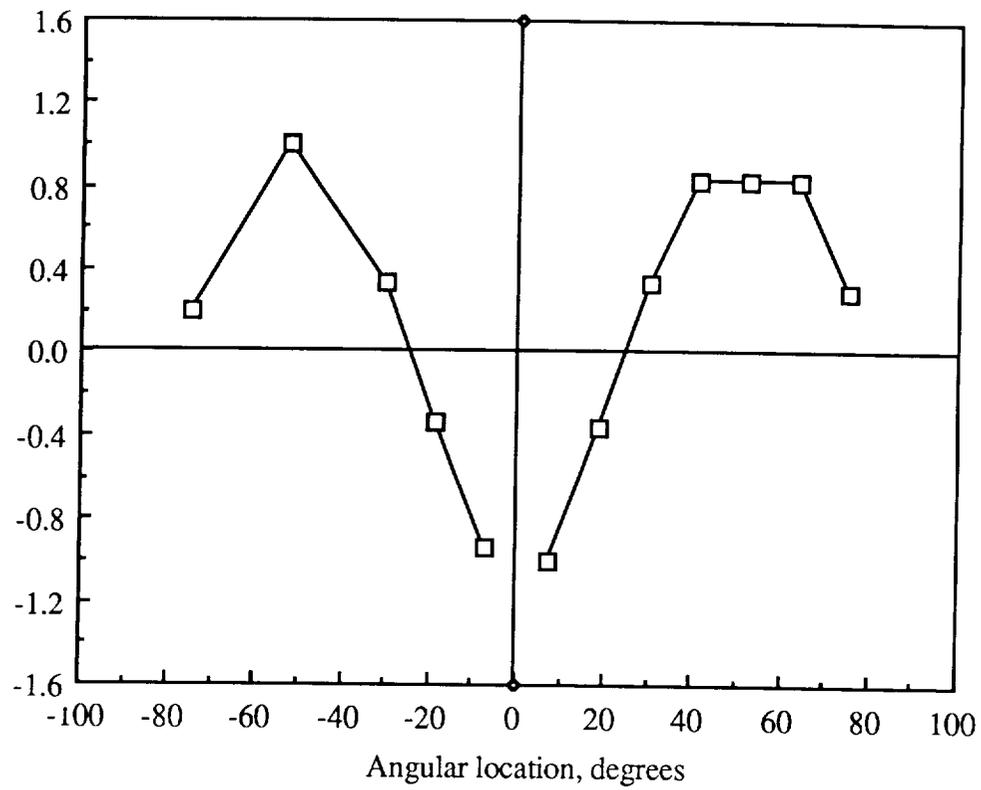
(c) Normalized strain distribution.

Dynamic tests.- Figure 17 shows the skeleton subfloor after an impact test onto a concrete surface at 20 feet per second. In the dynamic test of the skeleton subfloor, fractures were produced at notches in the frames (Figure 17(a)). The locations, shown in figure 17(b), were also near the point of impact (about 11° because of the splice plate) and at two other locations up the circumference of the frames ($\pm 45^\circ$ and $\pm 78^\circ$) and involve all three frames for a total of 15 fractures. The impact energy exceeded the energy absorbed by the local fractures and the floor bottomed out in the impact. Figure 17(c) is a normalized strain distribution measured on the first (end) frame during the dynamic test just before first failure. A comparison of the distribution to the moment distribution of Figure 14(b) and (c) shows essentially identical shape between the single frame and skeleton frame distributions. Maximums at 0° and at approximately $\pm 50^\circ$ to 55° agree well with the analytically predicted locations on the frame.

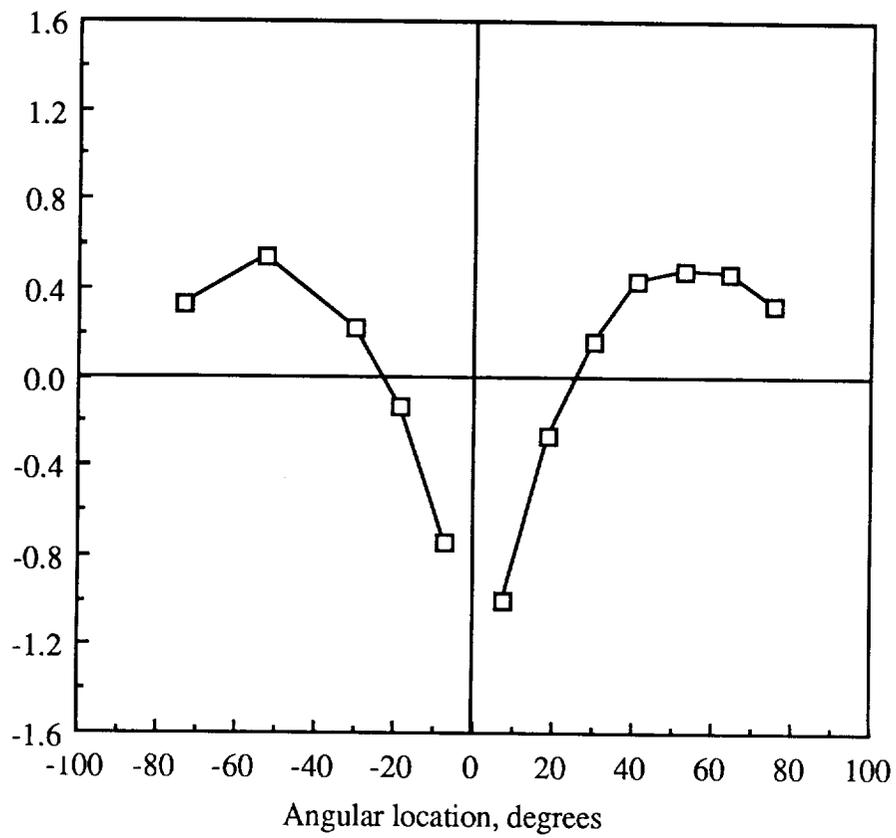
(c) Normalized strain distribution.

Figure 18 presents impact results for the subfloor with skin after an impact of 20 feet per second. Figure 18(a) is the subfloor specimen after the test. Points of failure of the frames in this specimen are indicated in figure 18(b). Again the points of failure are at/near the impact point (within 12°) and on the circumference at about $\pm 56^\circ$ up both sides of the frame on the middle and back frame and 11°, 22.5° and 45° on the front frame. It was observed that the subfloor impacted first on the front area which possibly explains the 11° and 22.5° fractures being different from the other locations. Again all three frames were involved in the failures. Some delamination of the frames from the skin was evident but the skin remained intact. Figure 18(c) is a normalized strain distribution (just prior to first failure) measured on the first (end) frame during the dynamic test. A comparison of the distribution to the moment distribution of Figure 14(b) and (c) and the strain distribution in Figure 18(c) shows essentially identical shape as the single frame and skeleton frame distributions. As was the case for the skeleton subfloor maximums at 0° and at approximately $\pm 50^\circ$ to 55° agree well with the analytically predicted locations on the frame.

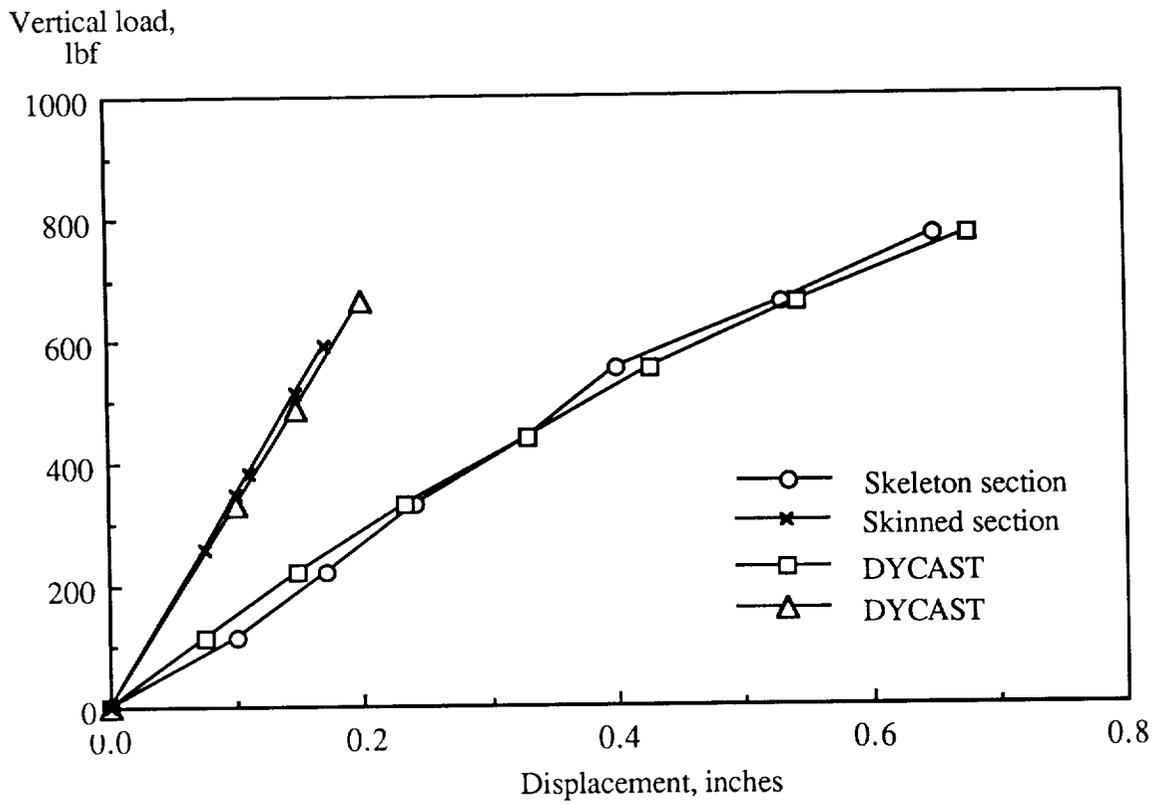
Figure 19.- Comparison of experimental and analytical stiffness of skeleton and skinned composite subfloors.

Analytical studies.-The contribution of the skin to the stiffness of the section with the antisymmetric frames is illustrated in figure 19. Static load-deflection data for the unskinned subfloor and the skinned subfloor along with the DYCAST predictions are shown in the figure. It can be noted that the subfloor stiffness (with skin) is approximately three times the stiffness of the skeleton subfloor, thus the skin's contribution to the structure is to maintain in-plane deflections of the non-symmetrical Z-section and prevent any substantial twisting of the frames. Out-of-plane bending and twist were allowed in the skeleton subfloor predictions. As a further note of interest, if for the skeleton subfloor, load in the load-deflection results (with three frames) is reduced by a factor of three, good correlation with single frame data is evident.

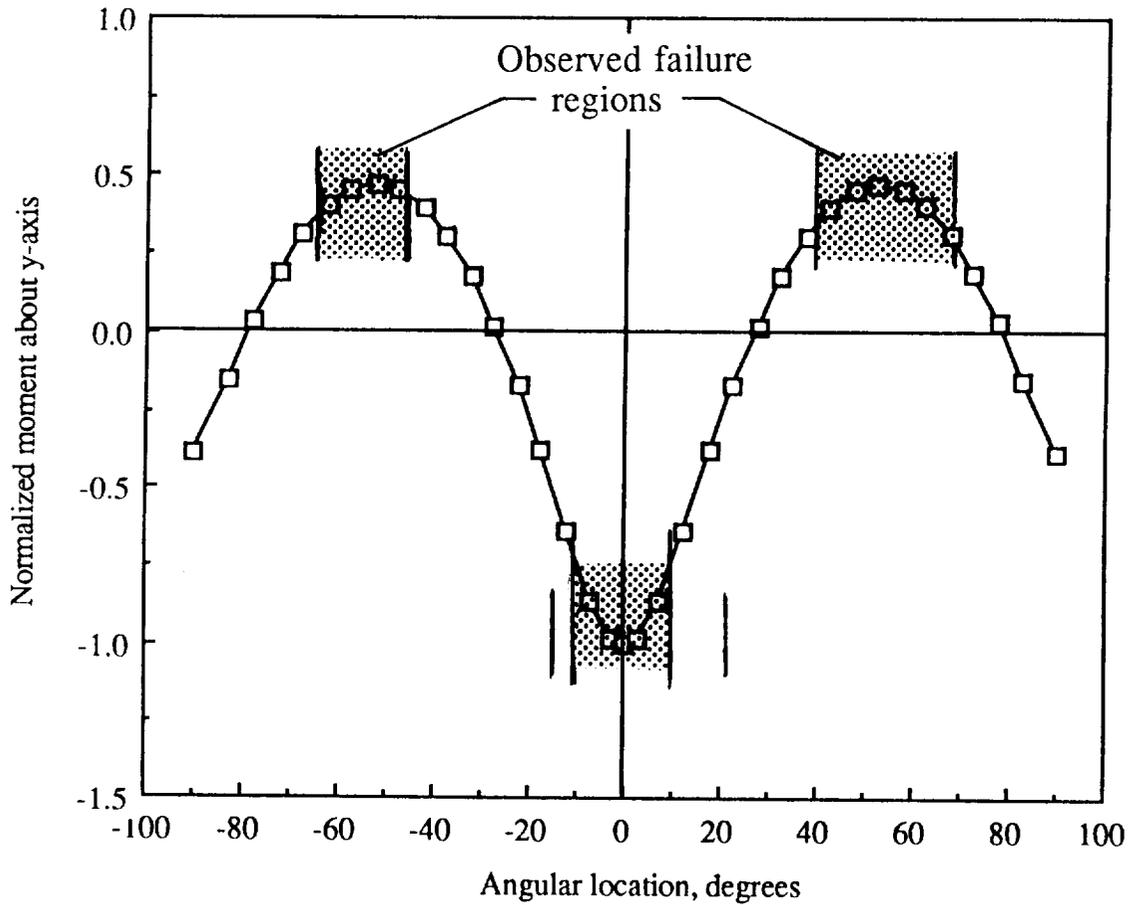
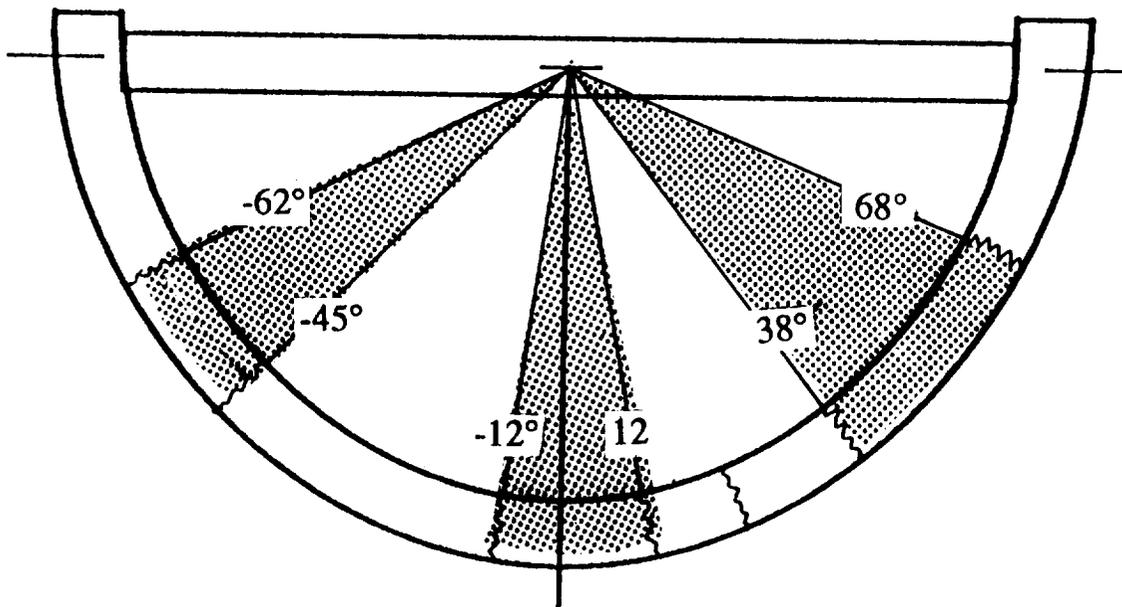
(a) Normalized moment distribution.

The response behavior determined during the studies of full-scale aircraft sections, fuselage panels, fuselage frames, and subfloors are summarized in figure 20. Figure 20(a) shows normalized moment distribution on a representative frame of the various specimens and Figure 20(b) shows the failure locations which were noted from static or dynamic tests. The visual impression is quite striking among the various specimens. It is suggested that from the results of simpler frames to the more complex subfloors and full-scale sections, a strong similarity is evident in the failure behavior of the structures. The structures share in
